**SO WE CRASHED  
OUR BUS...  
TWICE.**

ElDorado National Aerotech 240

Title 49, Code of Federal regulations – Part 571.301 fuel system integrity.

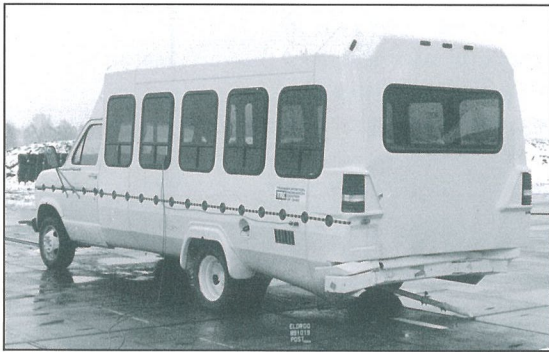
**30 MPH  
REAR  
IMPACT  
BY 4000 LB.  
MOVING  
BARRIER**

- Body structure- Attachment of rear wall and floor remained intact. Body structure sustained 5" permanent deflection while rear bumper sustained 11.1" permanent deflection. Rear window unaffected. Outer skin sustained cracks approx. 2" long at top, inside point of both taillight housings.

- Understructure-Chassis frame extensions at rear of vehicle where rear bumper attached, collapsed and shifted to the traffic side of vehicle. All welds and bolt fasteners remained intact. Fuel tank and associated assemblies were unaffected and no fuel spillage occurred. Floor structure remained attached to frame understructure.

- Interior- Floor and rear body seam remained attached. While all seats remained attached to mount assembly, backrests of two seats were bent slightly back. This was a result of 300lb. sandbags loaded in each seat to simulate passenger load. All egress windows and door remained fully functional.

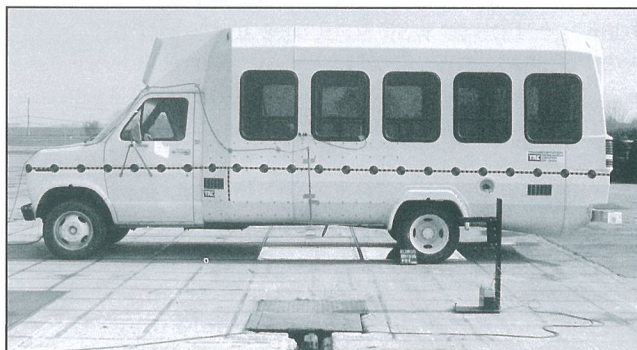
**30 MPH  
SIDE  
IMPACT  
BY 4000 LB.  
MOVING  
BARRIER**

- Body Structure- All body panel seams and wall to floor attachment remained intact. Wall sustained 4" permanent deflection. All windows remained intact with no breakage. Lower wall structure and skirt at forward most point of sidewall sustained majority of damage; e.g., exterior composite panel was cracked vertically up to bottom of forward side window. Skirt below floor line was broken away; approx. section 10" x 12".

- Understructure- Crossmembers moved approximately 10" with force of the impact; returned to approximately 6" of permanent deflection but remained fully attached to chassis frame. Driver's side chassis frame rail sustained approximately 1½" permanent deflection. All welds and bolt fasteners remained intact. Plywood floor sections all remained attached to floor seating rail and to crossmembers. Fuel tank and associated assemblies were unaffected and no fuel spillage occurred.

- Interior- Wall to floor marriage remained fully attached. All windows remained in place and fully functional. Side seating rail remained attached to wall and all seats remained fully attached to both wall and floor rail.
